Kabilash, Nepal Water Project

Introduction: The existing drinking water system in the village of Kabilash, Nepal was destroyed in the 2015 earthquake. We received a signed letter from the villagers asking for help, pledging labor and support to build and maintain a drinking water system. The majority of the villagers are subsistence farmers and 400 children attend school in the village from the surrounding area.

WFSV Project Report

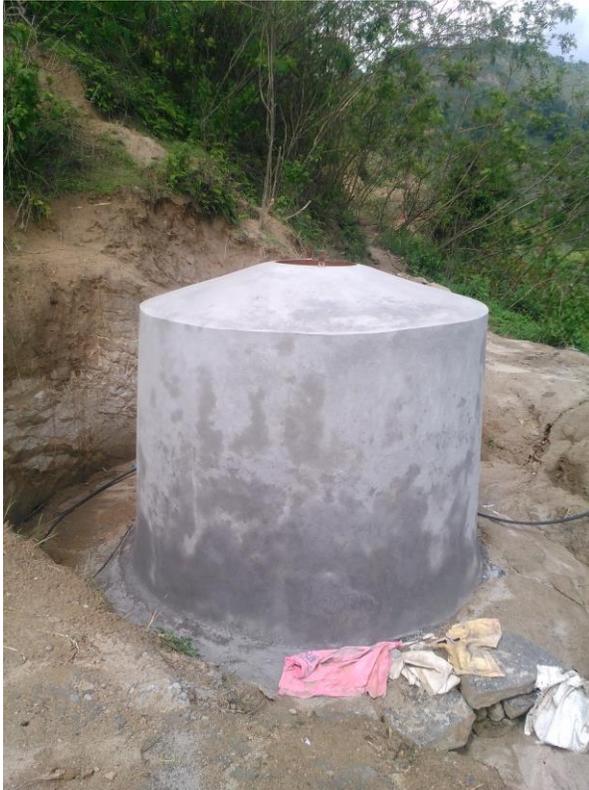
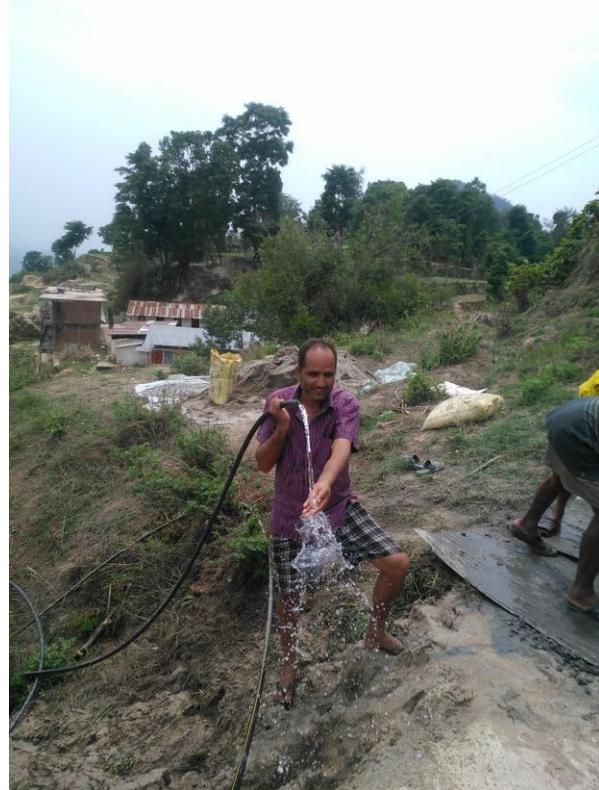
Photos of the phase I water tank and water delivery system.

Over the next two weeks after the team returned to the USA, the villagers completed installation of the system. They cleared rock, trenched a path following the natural curve of the ridge. 1,500 meters of 1 inch HDPE pipe was installed back to the proposed tank location. Sections of pipe were fused by hand using a propane heated disk. The water tank was constructed as designed. The mayor sent photos showing the completion of the work.

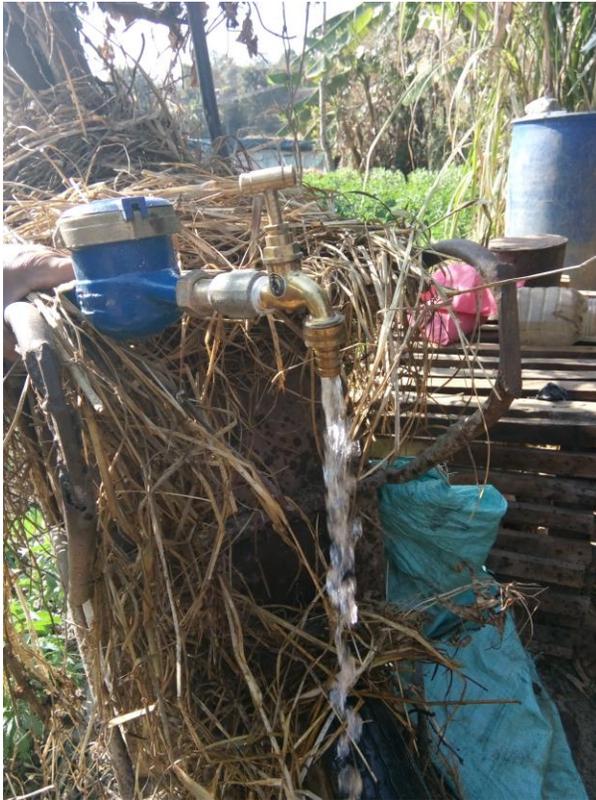
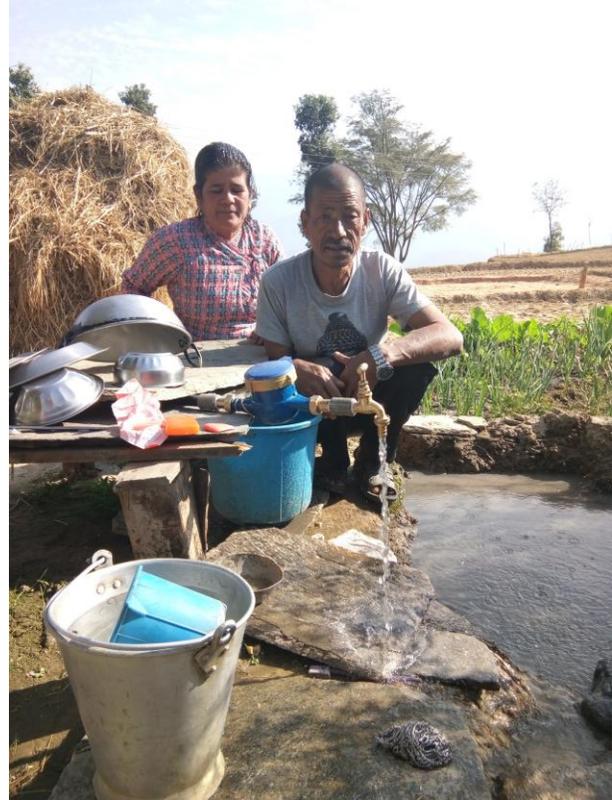
Photos from water meter installation in the lower village.

After 6 months maintaining the water system the villagers requested additional pipe to direct water to the lower village, nearer the homes. \$2,200 in funding was wired to Nepal and pipe was ordered and delivered using our existing business contacts we made in Phase I. Pipe was delivered and installed by the villagers to 6 locations where houses are clustered in the lower village. In addition the Napli government donated 16 water meters to help meet a new national standard to measure water consumption.
